Name Of Dam: BIG CHERRY DAM

Location: WISE COUNTY, VIRGINIA

Inventory Number: VA 19502

PHASE I INSPECTION REPORT NATIONAL DAM SAFETY PROGRAM

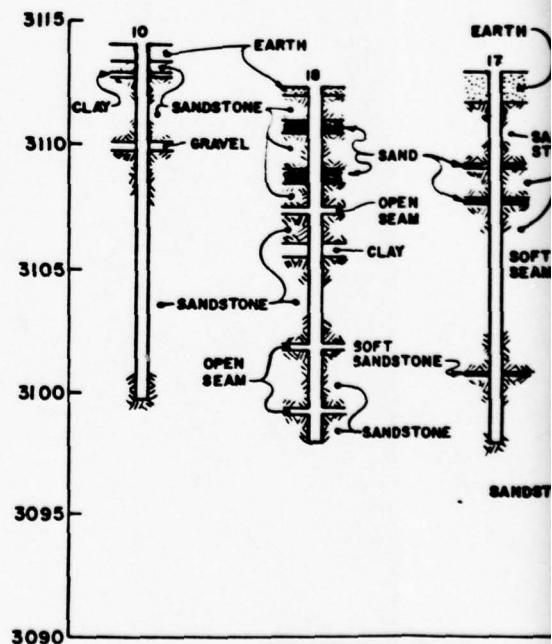
FIGURE 4
PLAN & SECTIONS
FOUNDATION TEST DRILLINGS

6.2 Foundation and Abutment: The open seams indicated on the attached figures seem to be parallel to the bedding planes and may have been originally caused by stress relief or shearing forces. The short durations of overtopping (see Table 5.1) are not likely to cause significant erosion at the abutments; however, increased seepage pressures along the weak seams during the floods are likely to cause sliding. Excessive seepage and resulting deterioration of strength along the weak seams or planes at shallow depths needs further examination and studies.
